# Project Specific Water Quality Management Plan

**Project Title:** First Day Street Logistics

**Development No:** PEN22-0144

**Design Review/Case No:** LWQ22-0030

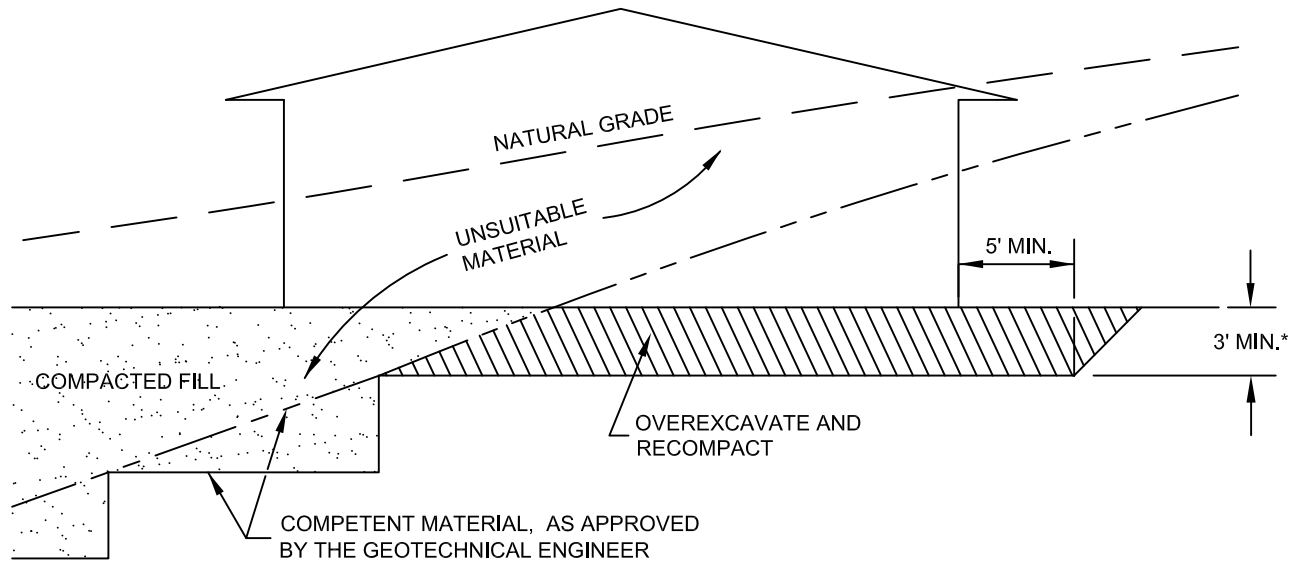
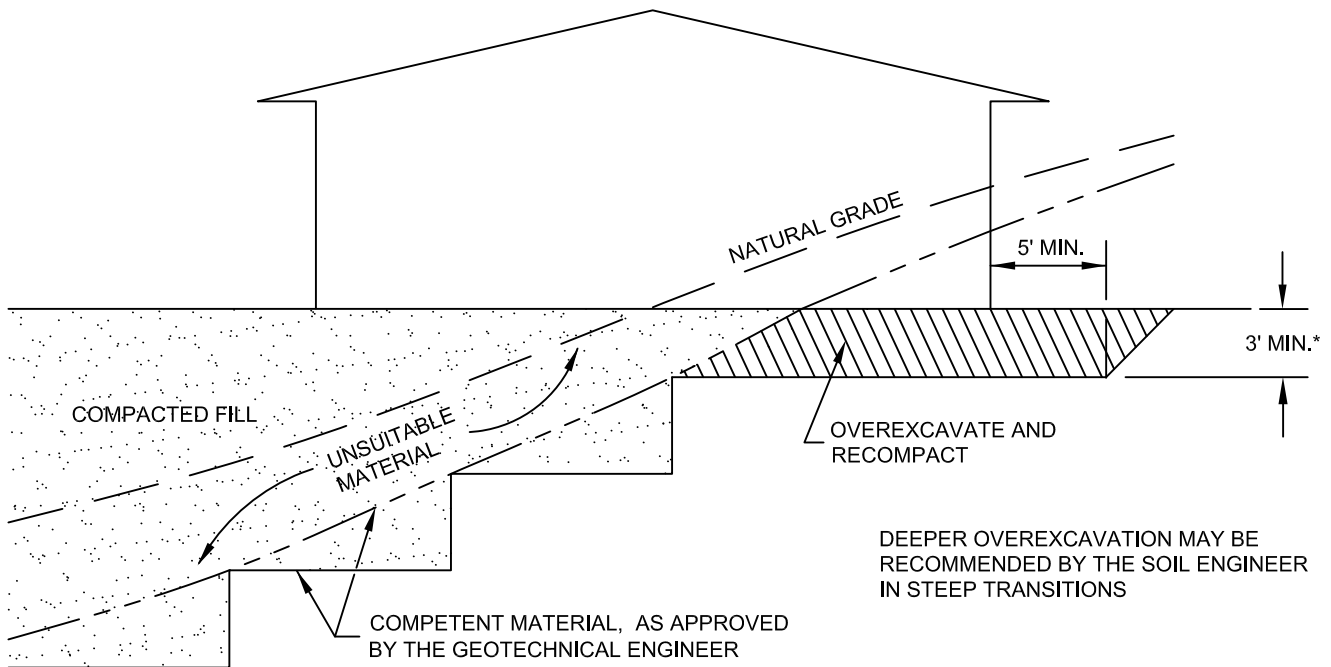
<b>TRANSITION LOT DETAIL</b>	
GRADING GUIDE SPECIFICATIONS	
NOT TO SCALE	  <b>SOUTHERN CALIFORNIA GEOTECHNICAL</b>
DRAWN: JAS CHKD: GKM	
<b>PLATE D-1</b>

\*SEE TEXT OF REPORT FOR SPECIFIC RECOMMENDATION. ACTUAL DEPTH OF OVEREXCAVATION MAY BE GREATER.

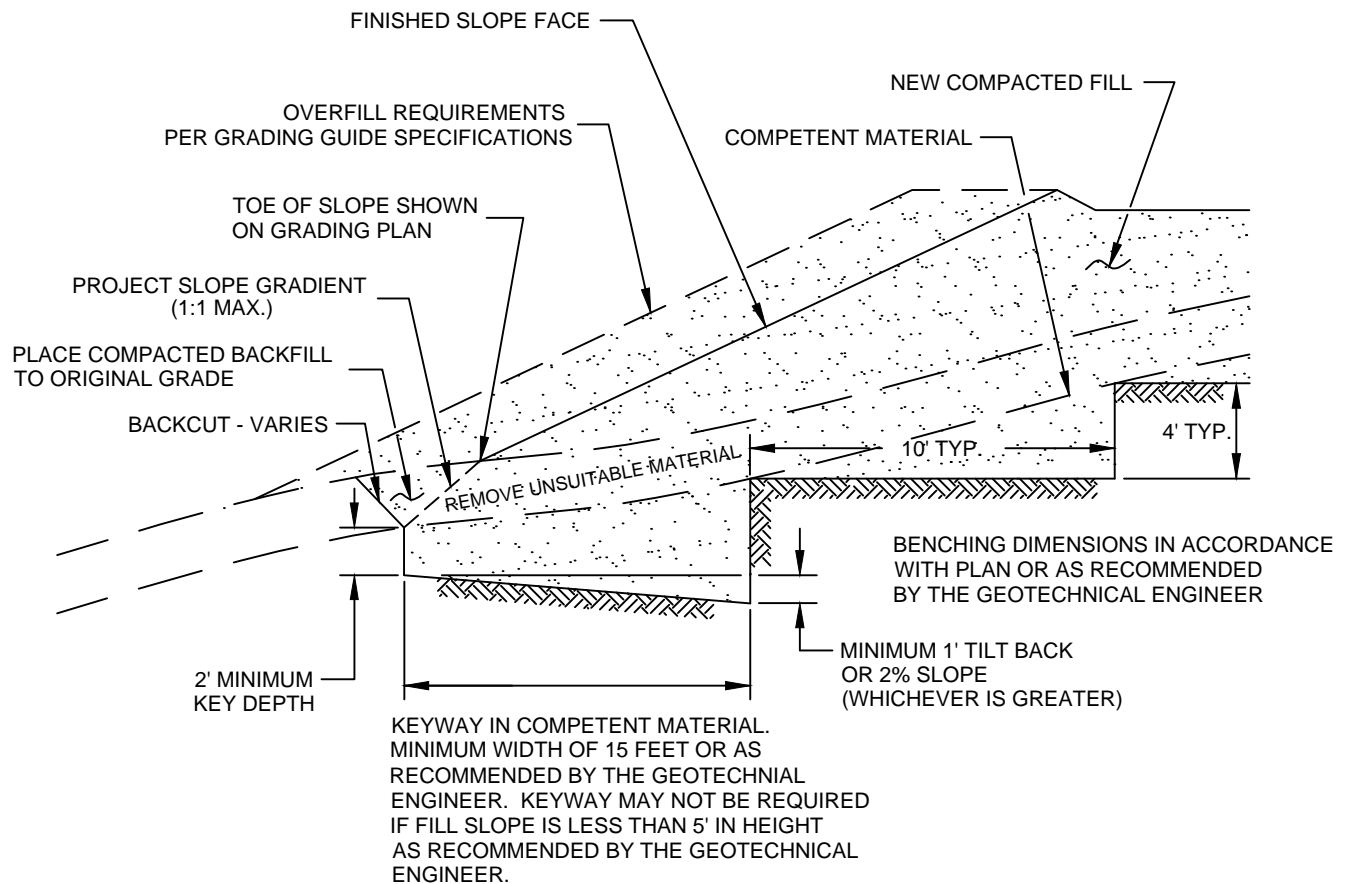
NOTE:  
 BENCHING SHALL BE REQUIRED  
 WHEN NATURAL SLOPES ARE  
 EQUAL TO OR STEEPER THAN 5:1  
 OR WHEN RECOMMENDED BY  
 THE GEOTECHNICAL ENGINEER.

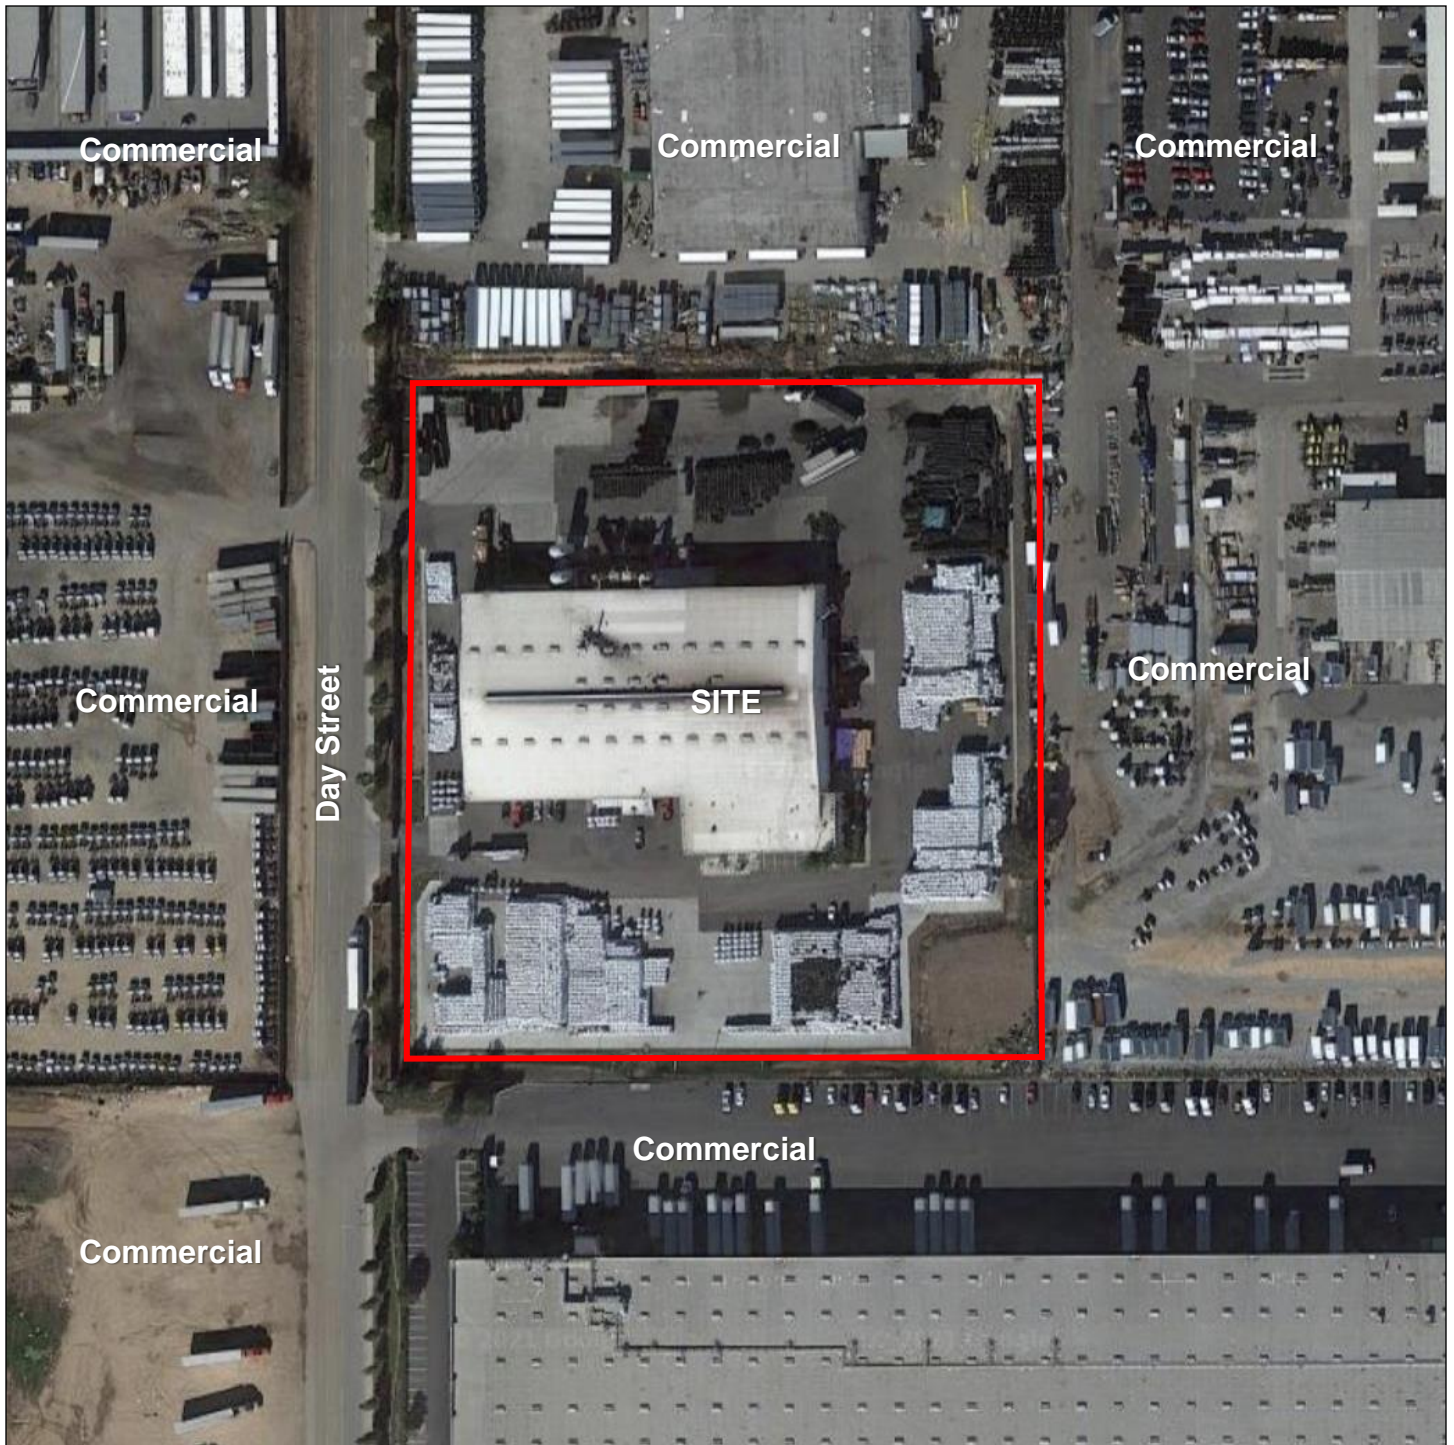
**Figure 2 - Site Plan**

**FIGURE 2**  
**SITE PLAN**

The Subject Property is a reported 7.82 acres and located generally north of Cactus Avenue, south of Alessandro Boulevard, east of Day Street and west of Elsworth Street. The Subject Property is further identified by Riverside County APN 297-130-036. A Vicinity Map is included as Figure 1. A Site Plan is included as Figure 2.

The seepage pit and clarifier were discovered at the Site during a test pit investigation in October 2020 (Figure 2). A scope of work to evaluate impacts to soil and groundwater in the vicinity of the seepage pit was submitted to DTSC in January 2021 and the investigation was performed in March 2021. The results of this investigation were presented to the DTSC in the May 17, 2021, Seepage Pit Assessment Report (Terraphase 2021b) and Seepage Pit and Clarifier Closure Work Plan was submitted to DTSC.

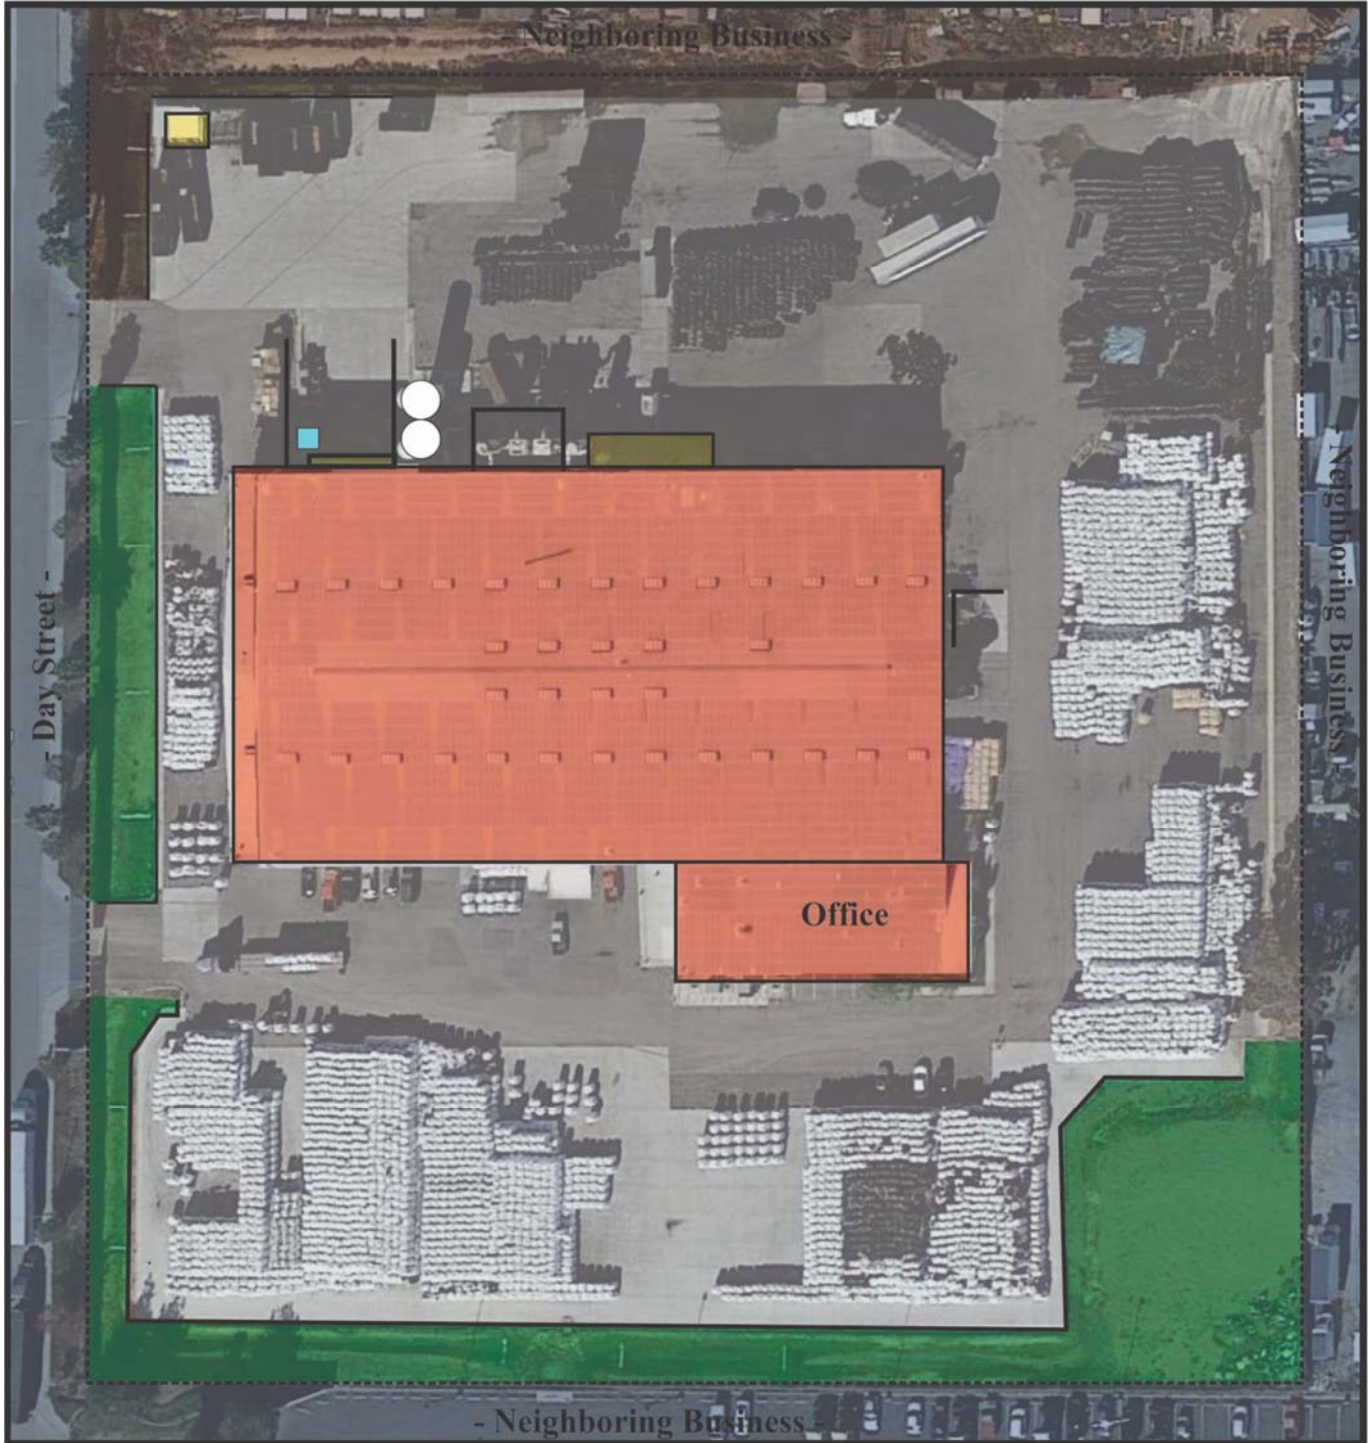
### FACILITY MAP

## Lakin Tire West LLC – Facility Diagram 14050 Day Street, Moreno Valley, CA

<span style="color: red;">■</span> - Building	<span style="color: blue;">■</span> - Neighboring Business	<span style="border: 1px solid black; border-radius: 50%; padding: 2px;">○</span> - Storage Tank	
	<span style="color: gray;">■</span> - Paved Area	<span style="color: green;">■</span> - Landscaped Area/Bio-swale	<span style="color: cyan;">■</span> - Sump Pump Inlet	
	<span style="color: yellow;">■</span> - Covered Area	<span style="color: brown;">■</span> - Unpaved Area

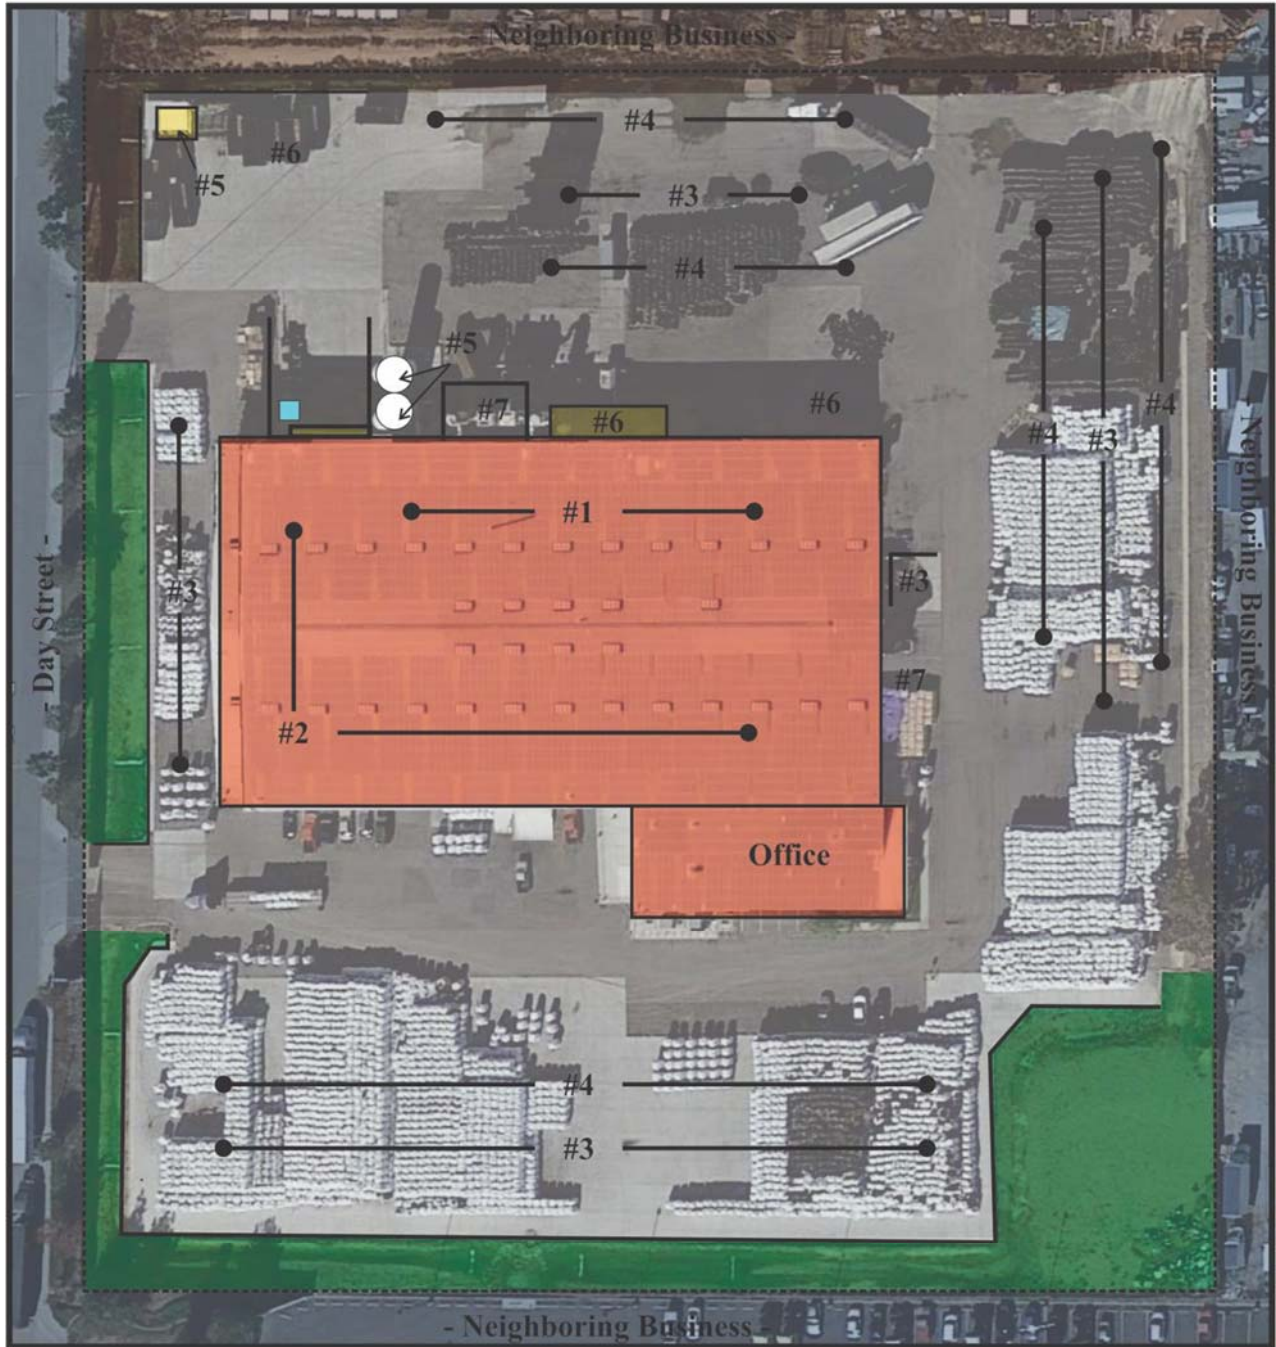
**POTENTIAL POLLUTANT DIAGRAM**

**Lakin Tire West LLC – Potential Pollutants Diagram  
14050 Day Street Moreno Valley, CA 92553**

<p>#1: Indoor Processing #2: Indoor Storage #3: Outdoor Storage #4: Loading / Unloading</p>	<p>#5: Hazardous Materials #6: Roll-offs #7: Facility Support Equipment #8: Operational Equipment</p>	<p>*Although not shown, Roll-offs and Operational Equipment occur throughout the Facility.</p>

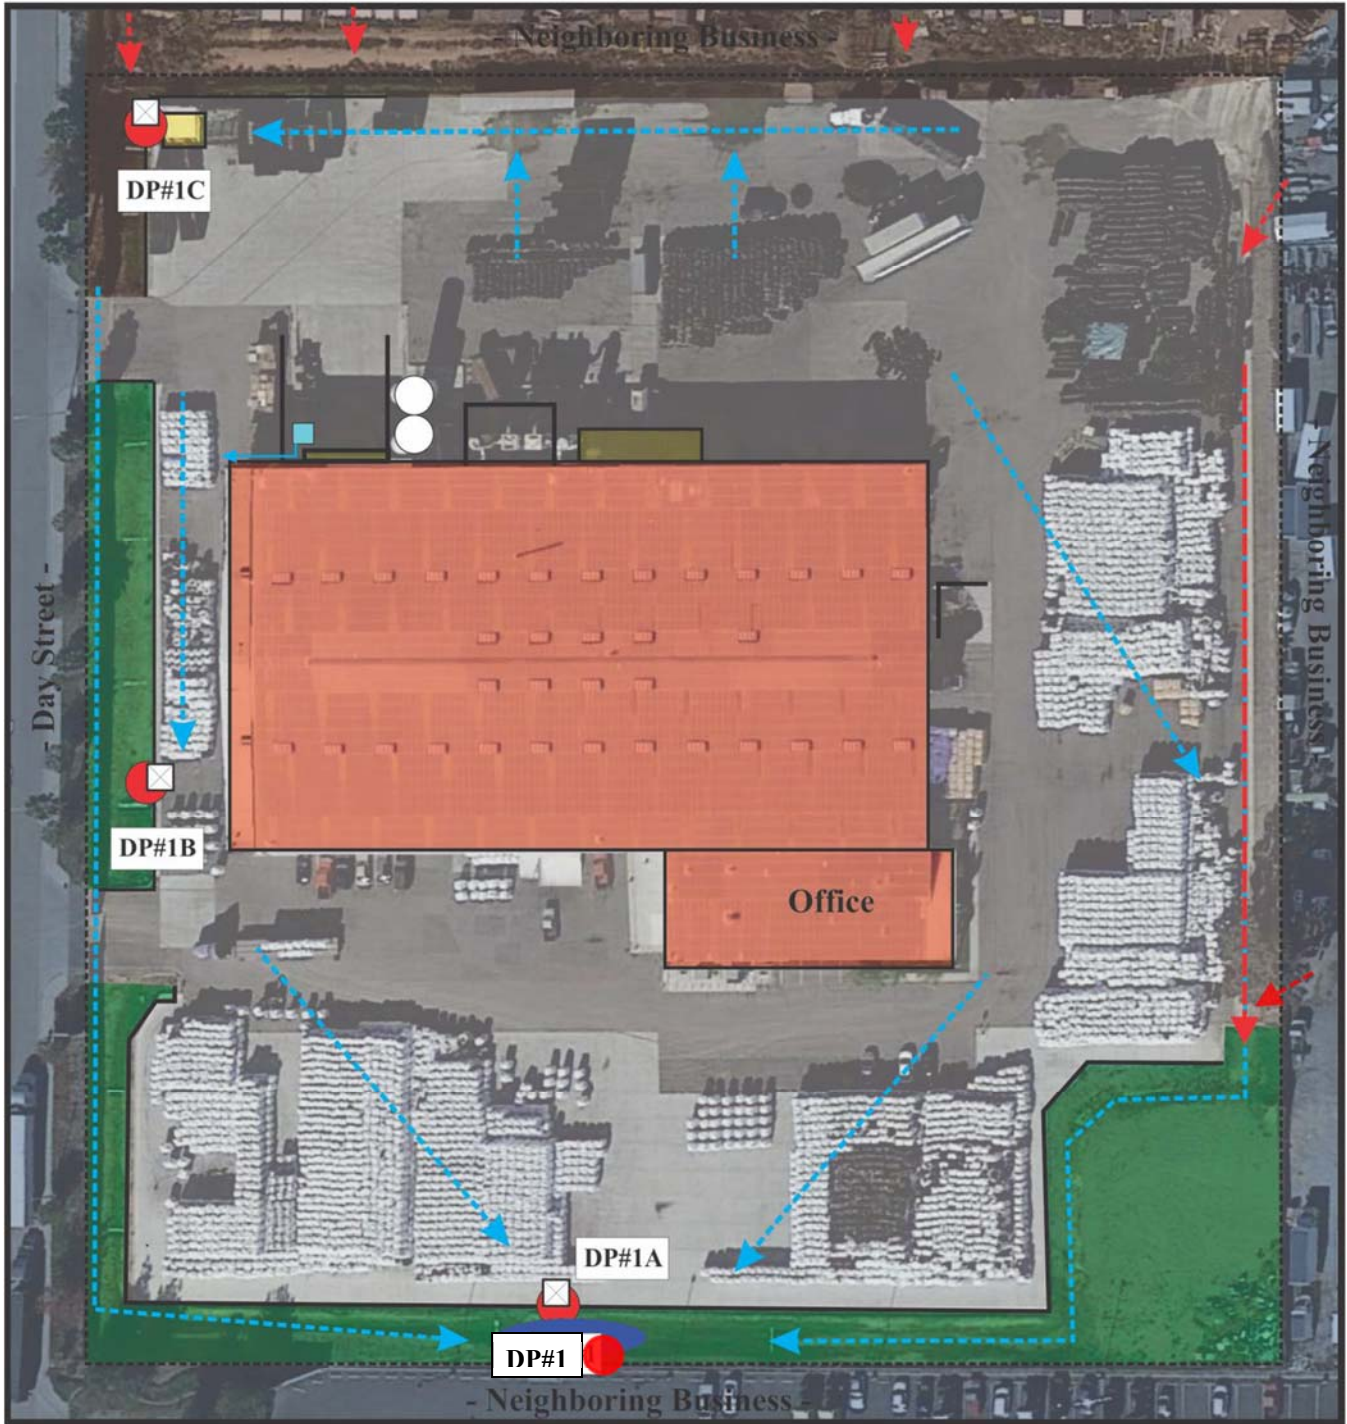
### MONITORING DIAGRAM

## Lakin Tire West LLC – Monitoring Diagram 14050 Day Street, Moreno Valley, CA 92553

- Storm Water Flow	- Sampling & Observation Point	- Drain/Curb Inlet	
	- Storm Water Run-on	- Pooling Area	- Sump Pump Inlet

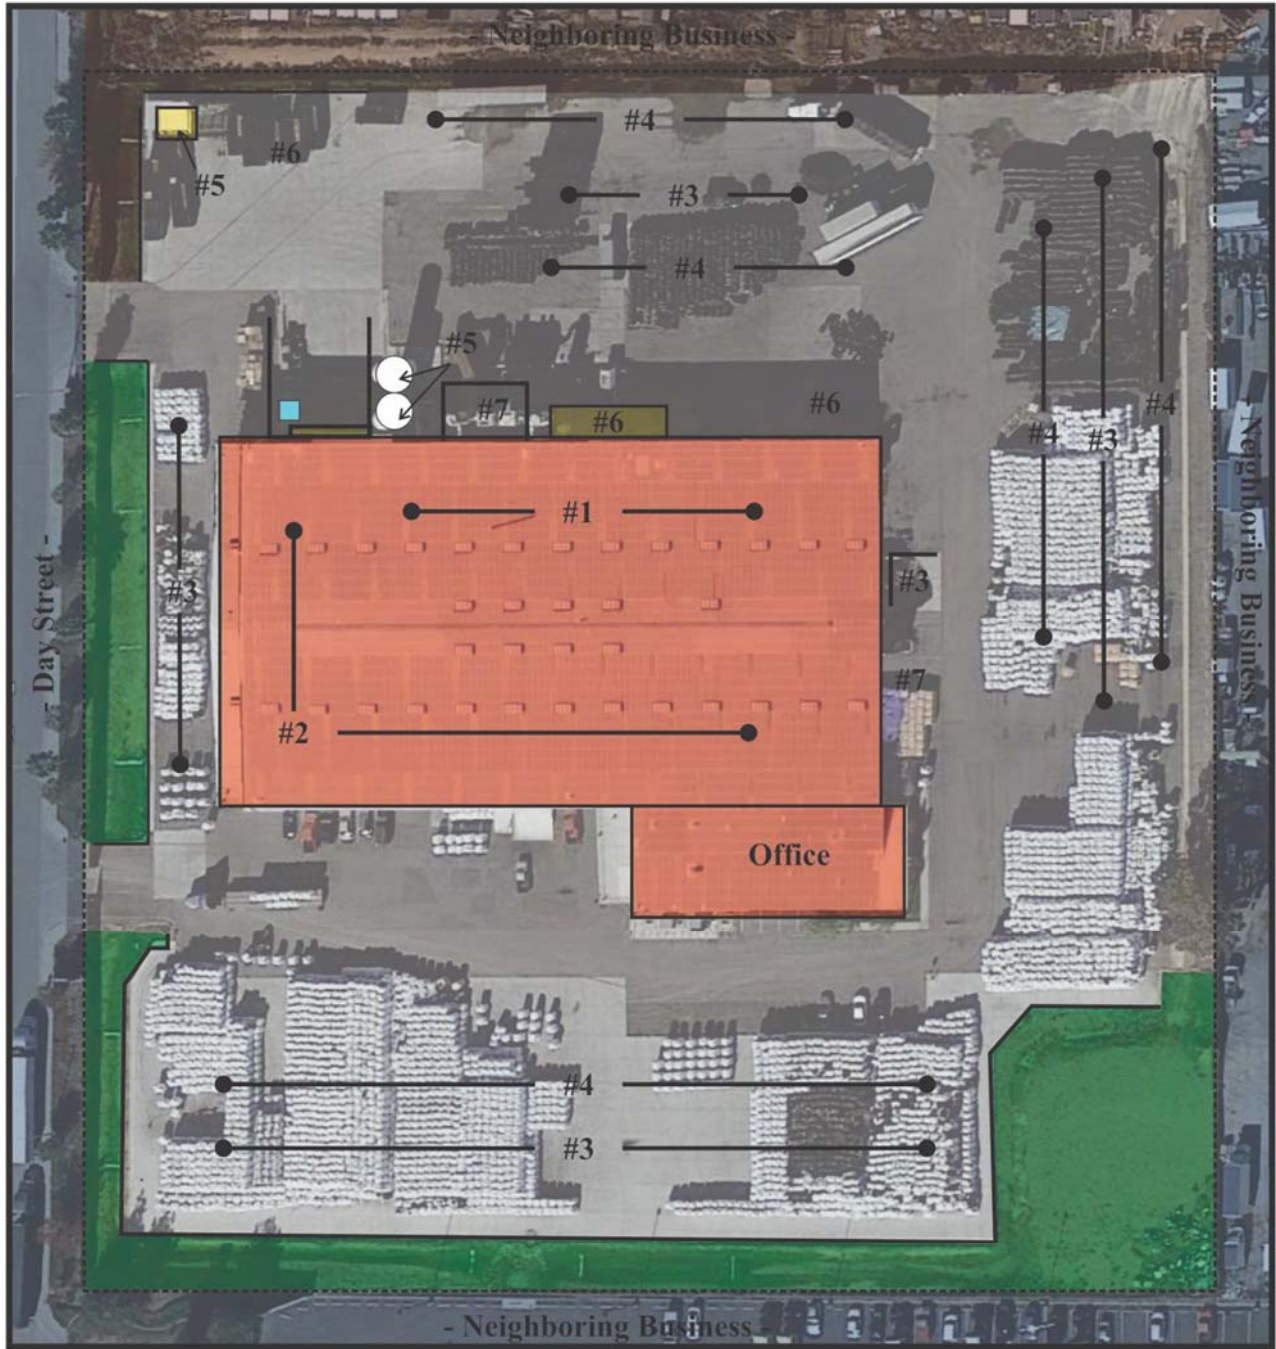
## POTENTIAL POLLUTANT DIAGRAM

**Lakin Tire West LLC – Potential Pollutants Diagram**  
**14050 Day Street Moreno Valley, CA 92553**

<p>#1: Indoor Processing      #5: Hazardous Materials</p> <p>#2: Indoor Storage        #6: Roll-offs</p> <p>#3: Outdoor Storage       #7: Facility Support Equipment</p> <p>#4: Loading / Unloading   #8: Operational Equipment</p>	<p>*Although not shown, Roll-offs and Operational Equipment occur throughout the Facility.</p>

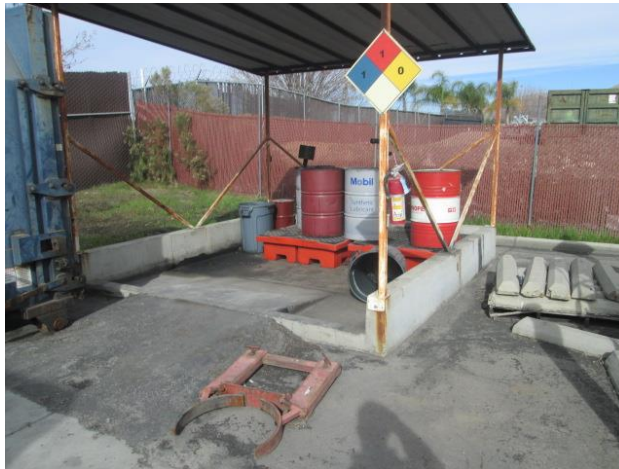
11. Used oil storage.

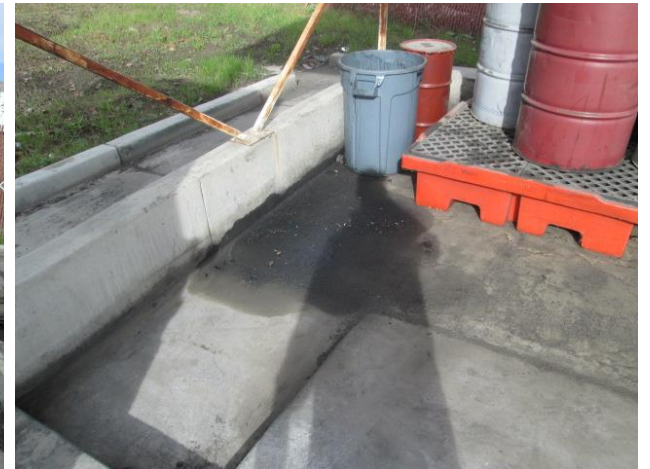
12. De minimis oil staining.

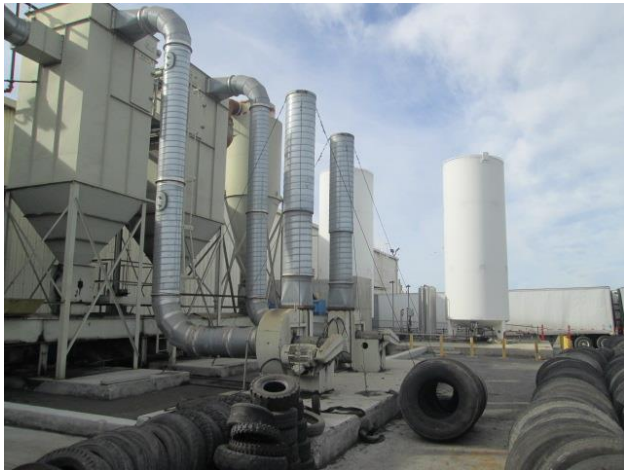
13. Liquid nitrogen tank (background) and dust collection systems (left).

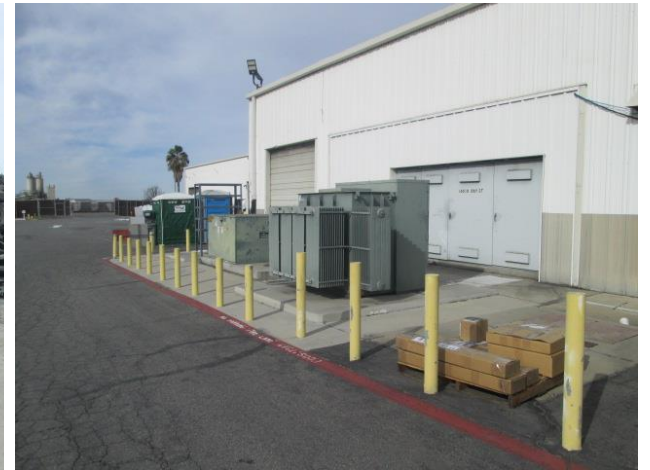
15. Electrical transformers.

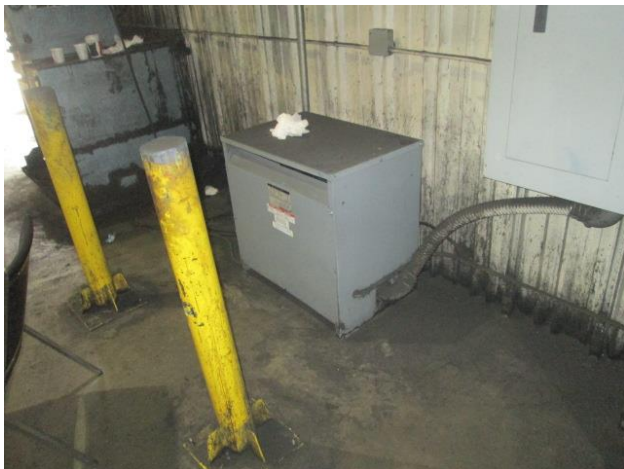
16. Typical transformer.

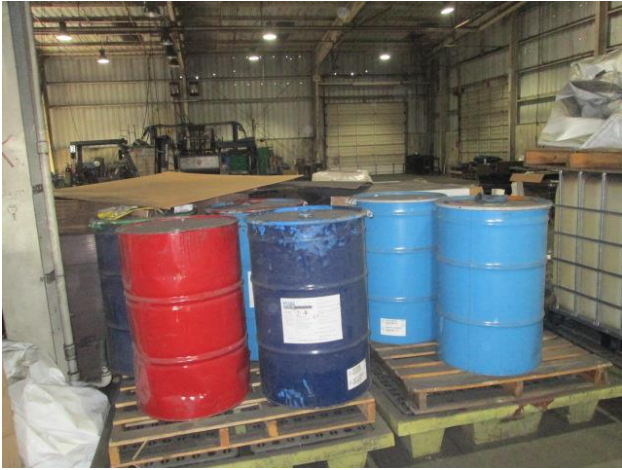
19. Typical drums of polyurethane binder.

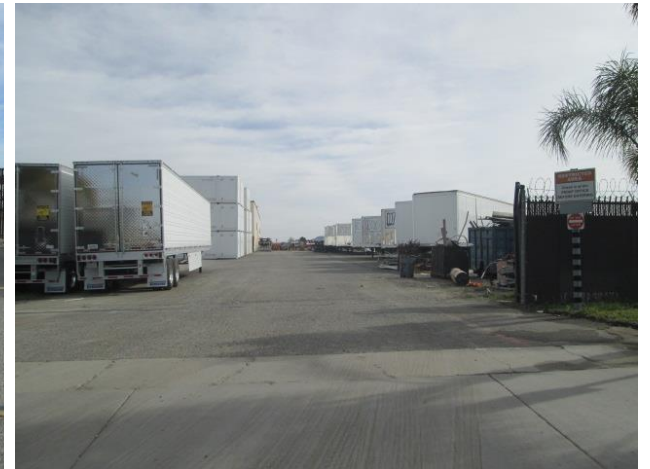
24. Northern adjacent property.

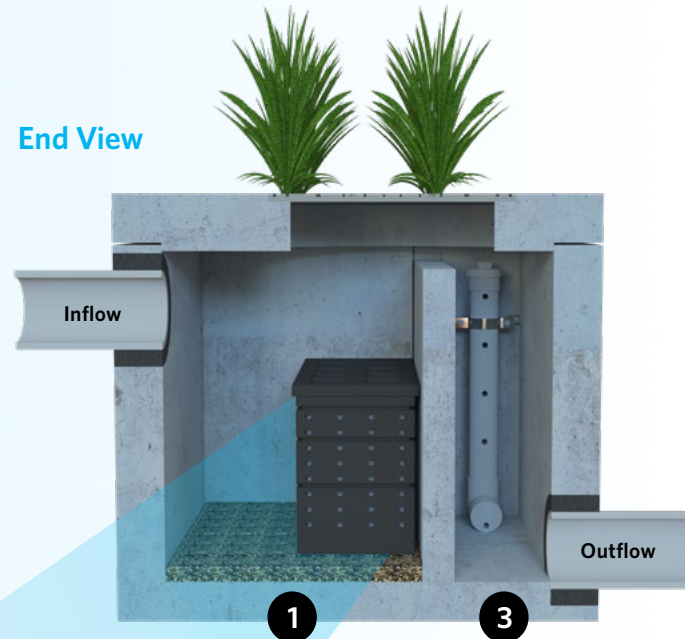
End View

- 1 Pretreatment Chamber
- 2 Biofiltration Chamber
- 3 Discharge Chamber

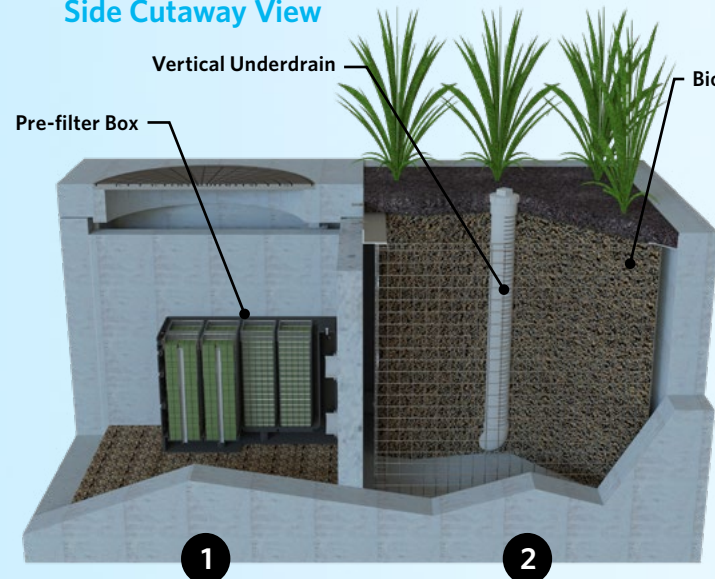
Side Cutaway View

- 1 Pretreatment Chamber
- 2 Biofiltration Chamber

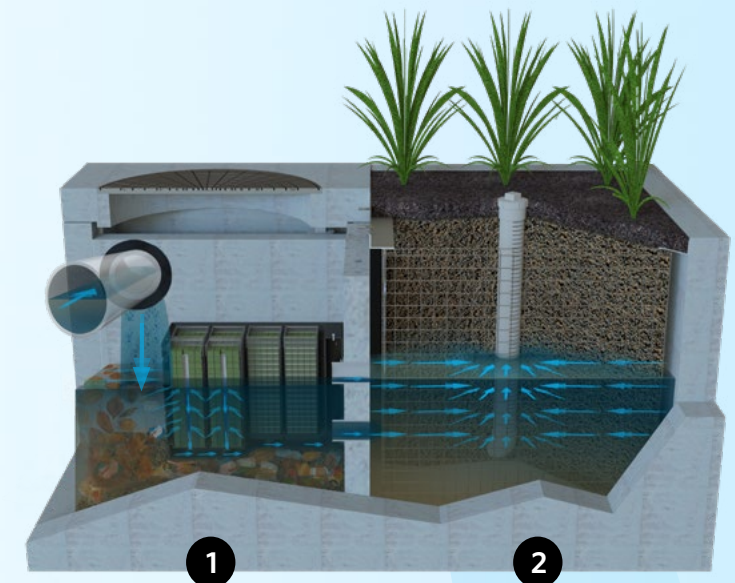
Stormwater and other pollutants all enter the pretreatment chamber first. The larger material remains contained within the pretreatment stage as stormwater travels through the pre-filter boxes and on to the biofiltration chamber. This design enhances treatment, prevents clogging, and expedites the maintenance process.

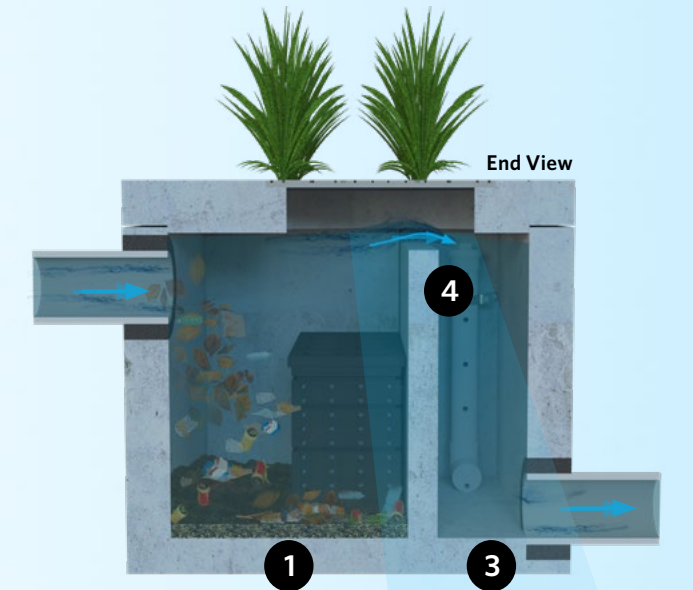
In the final stage or discharge chamber, the flow control riser (shown in the close-up) and the orifice plate, control the flow of water through the media to a level lower than the media's capacity. This extends the life of the media and improves performance.

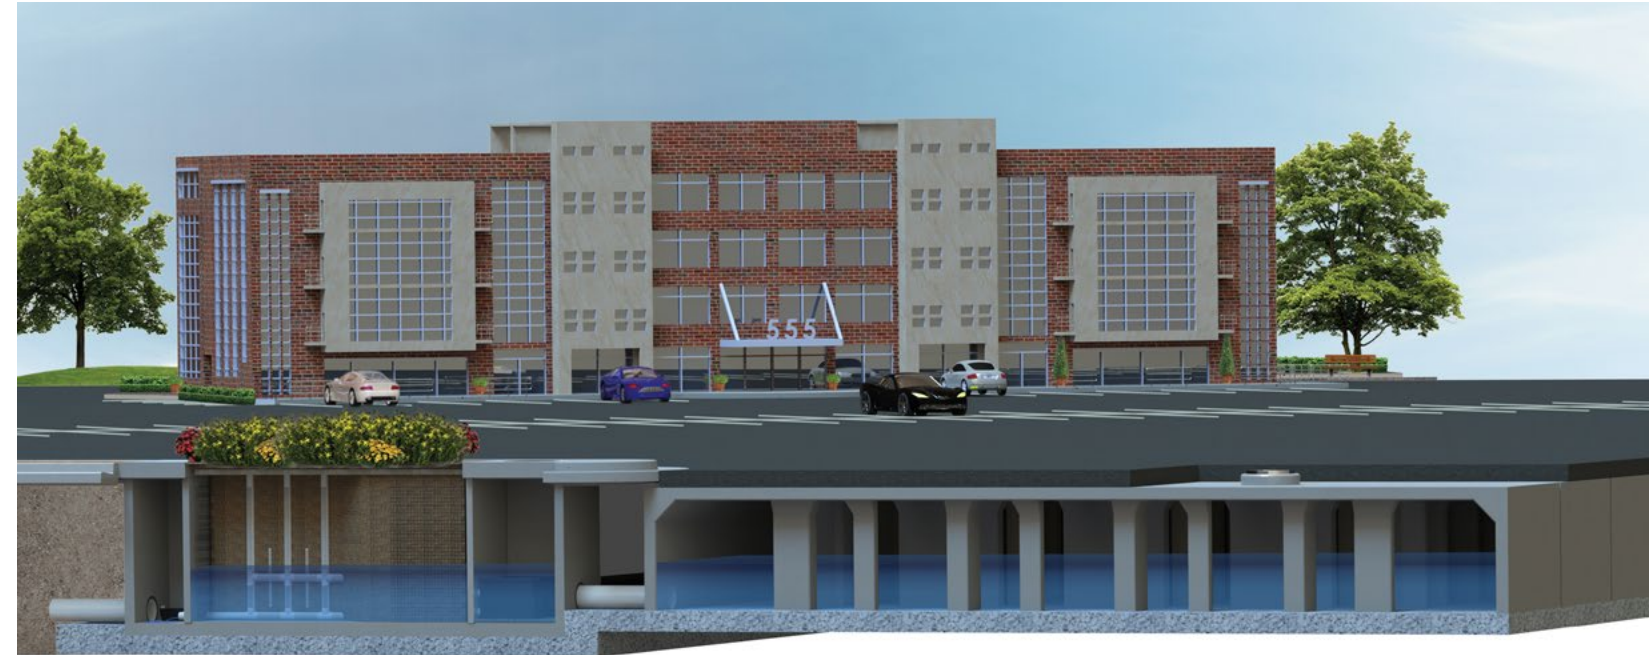
## VOLUME-BASED DESIGNS

In the example above, the Modular Wetlands Linear is installed downstream of the UrbanPond storage system. The Modular Wetlands Linear is designed for the water quality volume and will treat and discharge the required volume within local draindown time requirements.

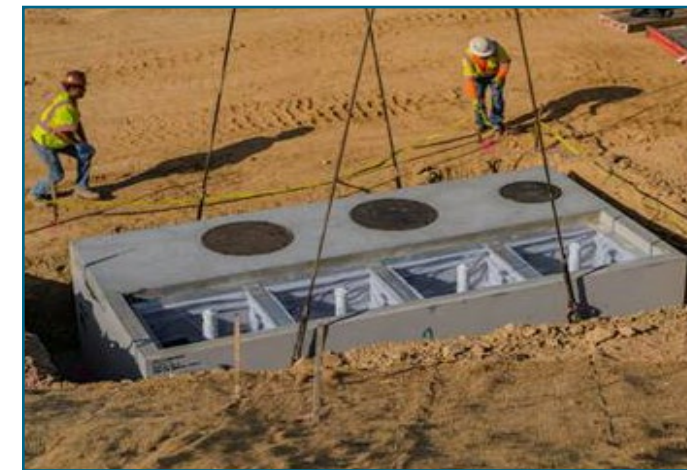
# INSTALLATION

The Modular Wetlands® is simple, easy to install, and has a space-efficient design that offers lower excavation and installation costs compared to traditional tree-box type systems. The structure of the system resembles precast catch basin or utility vaults and is installed in a similar fashion.

The system is delivered fully assembled for quick installation. Generally, the structure can be unloaded and set in place in 15 minutes. Our experienced team of field technicians is available to supervise installations and provide technical support.
