Project No. 33767.21

Subject: Phase II Environmental Site Assessment, Proposed Crystal Cove Apartments, APN 484-030-028, SWC Alessandro Blvd. & Lasselle St., Moreno Valley, Riverside County, California

PHASE II ENVIRONMENTAL SITE ASSESSMENT

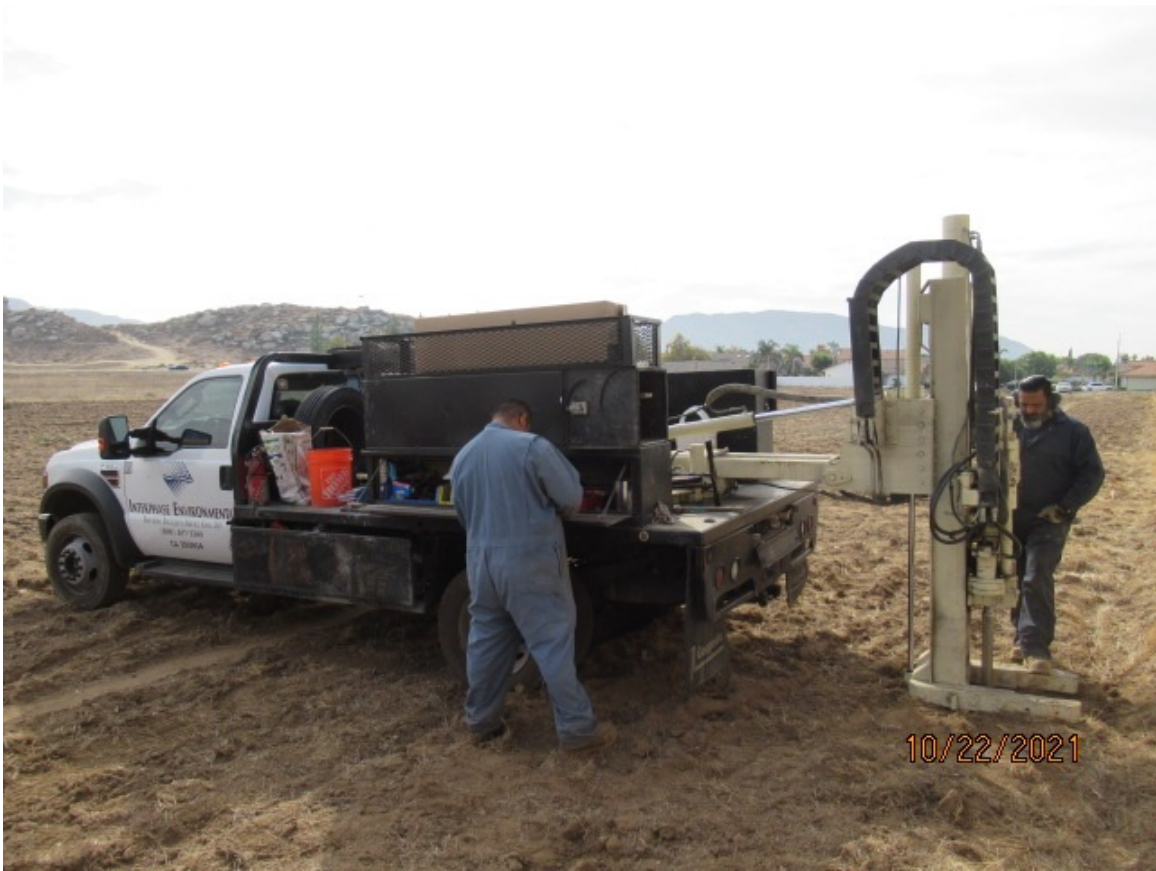
Photo 1 - The Interphase Environmental, Inc. direct-push rig is shown advancing the soil borehole at soil vapor probe location SVP-3 along the west side of the subject site, coincident with the offsite church building (location of former newspaper operation building) to the west.

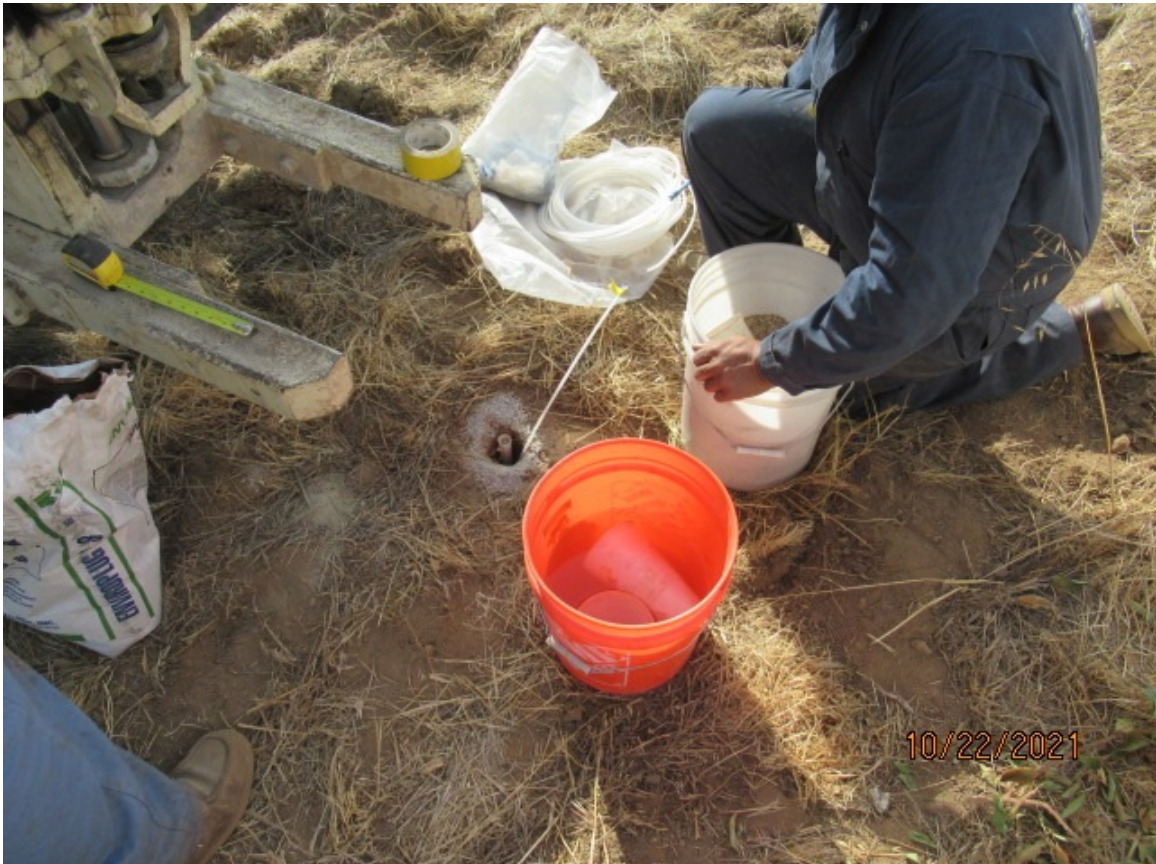
Photo 2 - Soil vapor probe construction at location SVP-5 is shown. The deeper 10-foot soil vapor probe is already installed with the 5-foot probe due to be installed utilizing the plastic pipe shown in the borehole next to the 10-foot soil vapor probe tubing. Construction materials include sand, bentonite granules, water, plastic tubing, and plastic probe tip inserts.

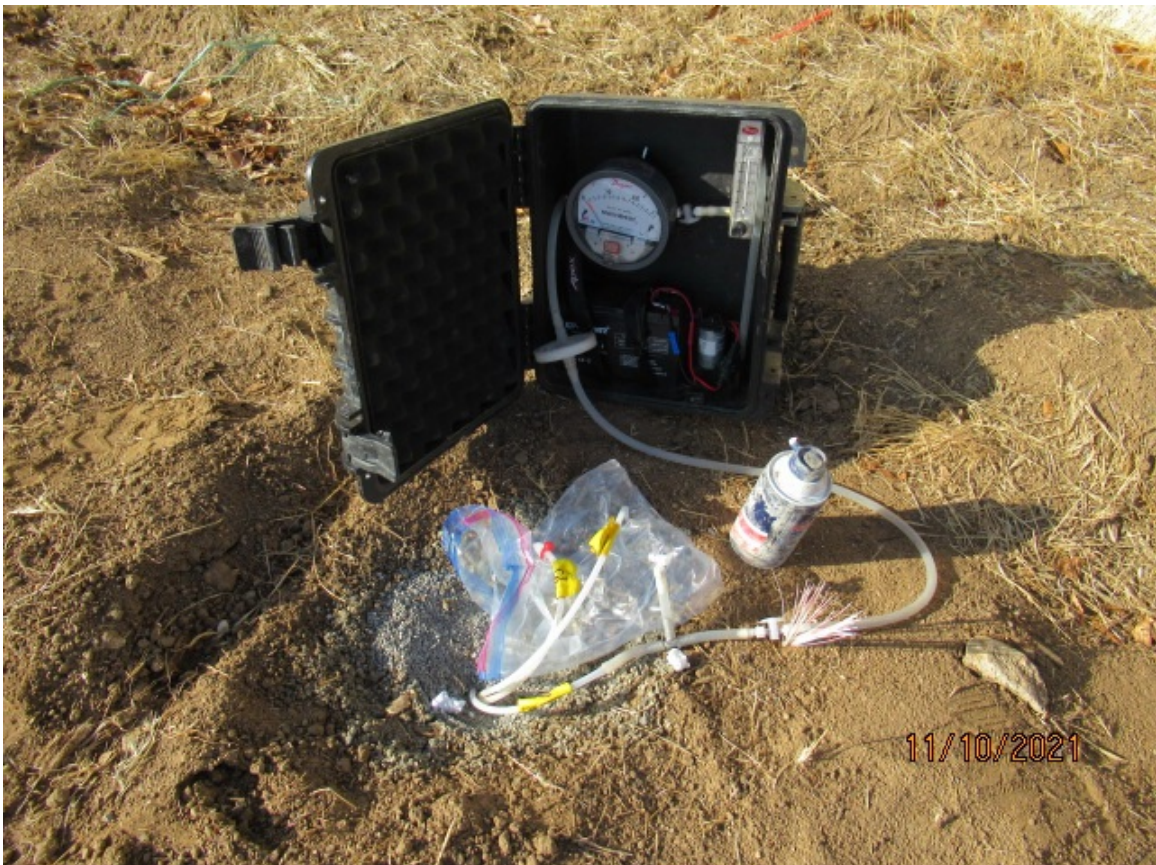
Photo 4 - An Optimal Technology mobile vacuum pump setup is shown connected to the 5-foot soil vapor probe at SVP-1 during purging, prior to sample collection and analysis. The shaving cream contains isobutane, a tracer compound for leak detection.

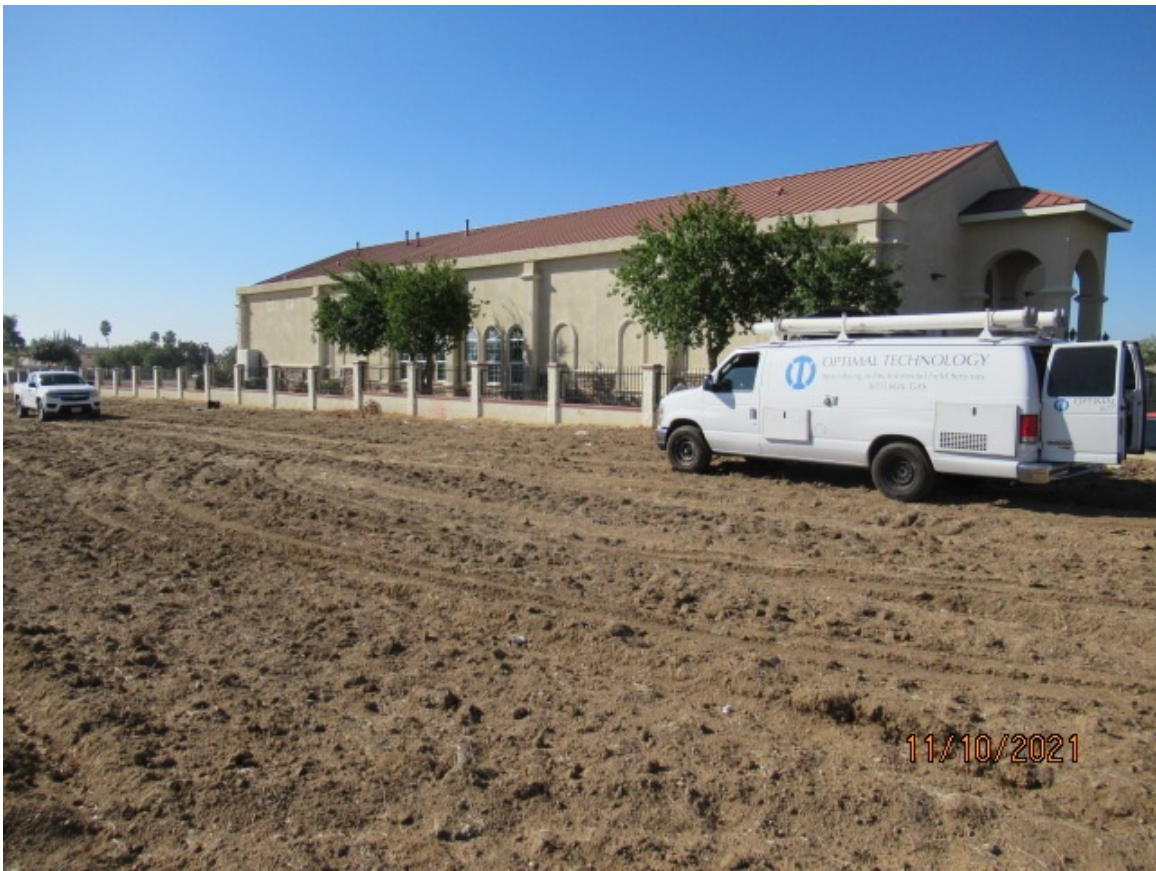
Photo 5 - Southwesterly view, looking towards the location at SVP-5. To the right is the Optimal Technology van, which includes a mobile laboratory. The soil vapor sample collection and analysis was performed by Optimal Technology personnel. The white truck to the left is coincident with and just east (left) of the location at SVP-3.
